AESTHETIC REHABILITATION OF A COMPLICATED CROWN-ROOT FRACTURE : A MULTIDISCIPLINARY APPROACH

Treatment for anterior teeth with subgingival fractures is complex, considering the biologic, functional, and aesthetic considerations. The treatment of a maxillary right central incisor with a complicated crown root fracture is covered in this case. The procedure was complicated; thus, an interdisciplinary approach was taken to restore the tooth. Fracture fragment was reattached with reinforcement from a 22-gauge stainless steel wire, made into a J hook. Endodontic treatment was done. The fracture line was exposed above the alveolar bone using orthodontic extrusion, followed by gingival margin recontouring. The tooth was reinforced with fiber post and core followed by a full coverage acrylic jacket crown. Good aesthetics and stable periodontal health were the outcomes of the treatment.

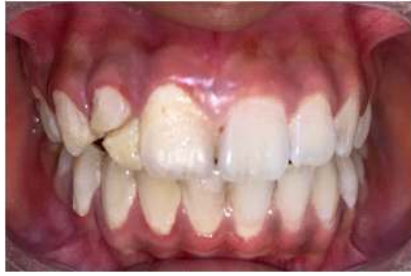
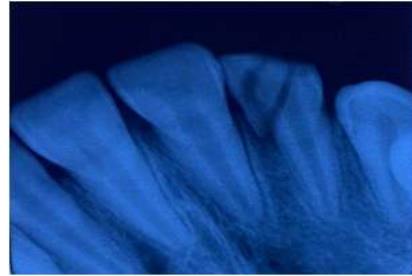
A 13-year-old female patient reported to the department of Pediatric and Preventive Dentistry with a chief complaint of broken right upper front tooth due to fall four days back. Clinical examination revealed, fractured 12 with a hanging fracture fragment. Patient had moderate pain that aggravated on touch, was tender on percussion. Pain relieved on taking medications. Subgingivally, the fracture line extended on the mesial aspect 2mm beyond the alveolar bone as seen on the radiograph. IOPAR revealed a complicated fracture, with the fracture line involving the pulp [Fig1]. There was no evidence of extraoral or intraoral laceration. No relevant past medical or dental history was reported. Hence a diagnosis of Ellisclass III fracture (with subgingival extension) with symptomatic apical periodontitis with respect to 12 was made.

Fig1: Pre-operative clinical and radiographic findings

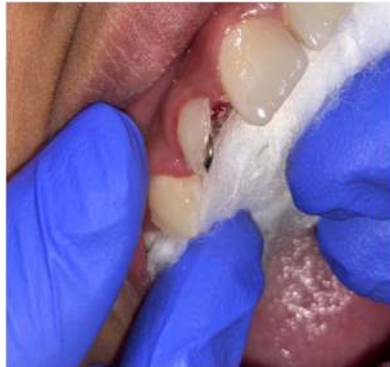
Fig2a: Stainless steel wire fragment placed in canal.

fragment was then repositioned with reinforcement with the stainless-steel wire fragment [Fig2a] into the canal by light cure flowable composite (Ivoclar Vivadent Te-Econom flow refills flowable composite resin-A2). The remaining fractured portion of the tooth was also built up and recontoured with bulk filling composite restoration (Ivoclar Te-.Econom Plus composite Refill-A2).

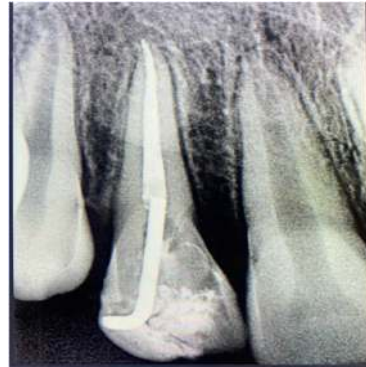
Fig2b: Radiograph showing obturation of 12 followed by reattachment of the fractured fragment with SS wire fragment.

expose the fracture line; c) Gingivectomy for aesthetics and further exposure; d) Post endodontic restoration of 12 (post core fabrication followed by acrylic jacket crown). Accordingly, the infected pulp was extirpated, profuse bleeding was observed due to pulp hyperemia. 5.2% hypochlorite solution was used for irrigation followed by normal saline. Canal was dried with absorbable paper points, Ca(OH)₂ paste was used as intracanal medicament followed by Zinc oxide temporary restoration. The patient was recalled after 14 days. As tooth was found asymptomatic it was obturated with gutta percha and zinc oxide eugenol sealer. The fracture fragment, which was soaked in distilled water, was grooved to receive a 22-gauge stainless steel wire fragment. Cervical portion of the gutta percha was removed from the canal. After proper isolation, both the fracture fragment and the canal were etched (Prime dental etching gel etchant -3Gm), dried and bonded (FGM Ambar bonding agent- 4ml). The fracture

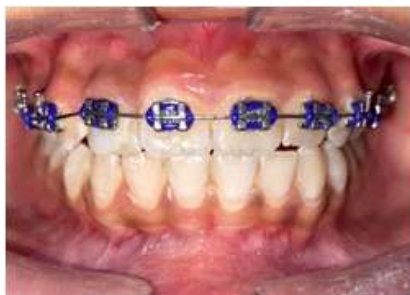
Fig3 : Bonding of teeth with MBT bracket system

The teeth were bonded with MBT brackets. The bracket on 12 was placed apically to allow extrusion of the tooth. 0.012" NiTi (nickel titanium) wire was secured to the brackets.[Fig3]. The wires were changed sequentially to higher wires until 0.018" SS wire. The 0.018" SS wire was stepped down to 2mm with respect to 12 maintaining the arch form. E-chain was used to tie the wire to the bracket slot to aid further extrusion [Fig4]. An extrusion of 4mm was achieved within 9 weeks followed by a retention phase of one month.

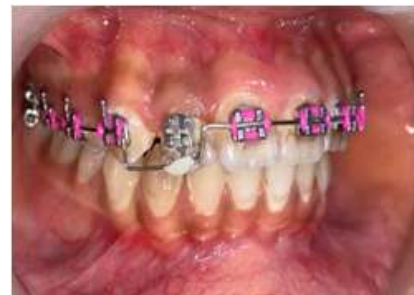
Fig4 : The 0.18" SS wire has been stepped down

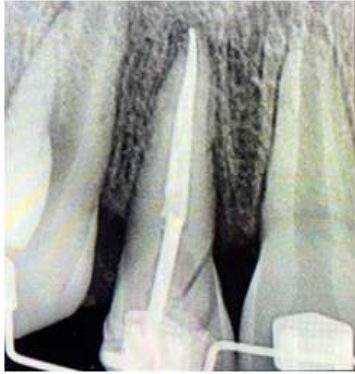
Fig 5: radiographic evidence showing fracture line coronal to alveolar bone.

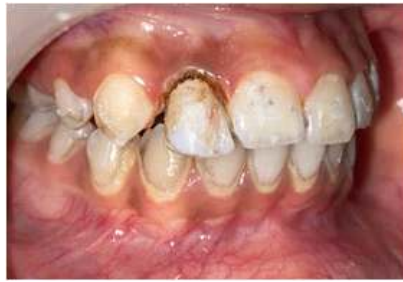
Fig6: LASER gingivectomy done with respect to 12

Once the desired extrusion was achieved and retained, the patient underwent DIODE LASER gingivectomy with respect to 12 for aesthetic gingival margin and more exposure of the fracture line [Fig 6]. On the very same day the fracture fragment was removed, and the stainless-steel wire fragment was separated and discarded. Post space was prepared, fiber optic post was cemented with resin cement. Reattachment of the fracture fragment without the stainless-steel wire fragment was done. Tooth preparation was done, followed by cementation of an acrylic jacket crown on the very same day to completely cover the exposed fracture line [Fig7]

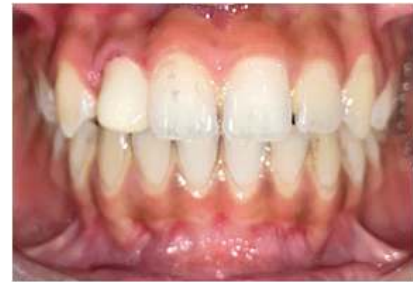
Fig7: Final post-op photograph after acrylic jacket crown cementation
