SINGLE-VISIT ENDODONTIC TREATMENT WITH IATROGENIC CERVICAL ROOT PERFORATION REPAIR ON MAXILLARY RIGHT CENTRAL INCISOR BY GUTTAFLOW BIOSEAL : A CASE REPORT

Dr. Chiranjan Guha*, Dr Ipsita Maity**, Dr Paromita Mazumdar***

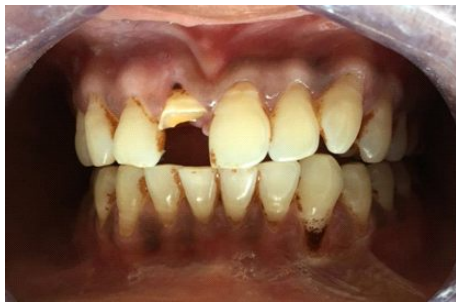
Figure 1 : Pre-operative photograph of tooth number 11

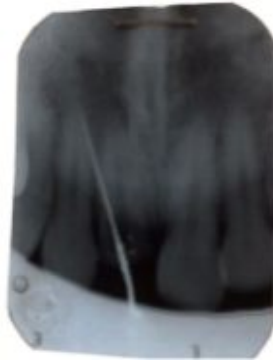
Figure 2 : IOPA radiograph of tooth 11 with 25 k file placed through the perforation

An intraoral periapical radiograph was taken with a #25 size K file placed in the perforation, which

aided in further localizing the site of the perforation (Figure 2). A slight periodontal ligament (PDL) widening was seen in the periapical region with the associated tooth.

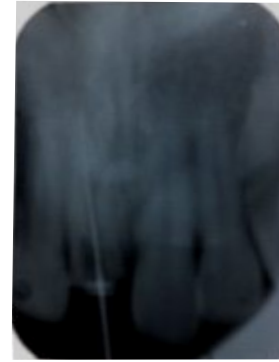
Figure 3: IOPA radiograph of tooth 11 with 25k file to determine the working length

The lateral walls of the perforation were refined and cleaned. A #25 size K file was used to establish the length from the incisal reference point up to the perforation site inside the root canal. Working length was established with a #25 size K file. (Figure 3).

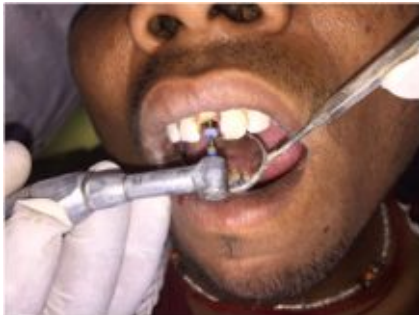
Figure 4 : Canal preparation upto file F3

Cleaning and shaping was done using the ProTaper file system upto file size F5 (Figure 4).

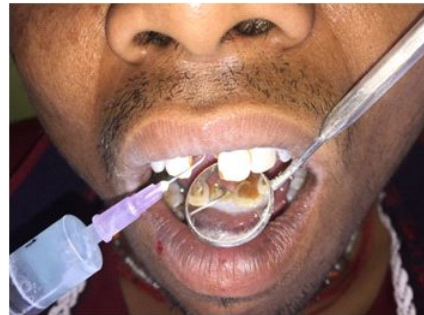
Figure 5 : Irrigation of the prepared canal

Canal was irrigated with 1.5 mL of 2.5% NaOCl. After each instrumentation, in order to remove the smear layer, 3.0 mL of 17% EDTA was introduced and allowed to remain in the canals for 3 minutes and then a final flush with 1.5 mL of 2% CHX was performed. (Figure 5)

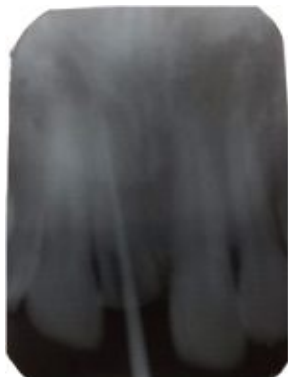
Figure 6: IOPA of master cone selection

Master cone selection was done by intra-oral periapical radiograph (Figure 6). The access cavity and perforation defect were dried. GuttaFlow Bioseal was mixed and carried to the perforation site with the help of lentulo spiral and packed with an appropriately fitted plugger. Repair of the perforation was carried out by progressive placement and packing of small increments of the sealer. The root canal was obturated with the same sealer such that the sealer was allowed to flow out of the access cavity (Figure 7). The Mineral Trioxide Aggregate was allowed to set for approximately four hours.

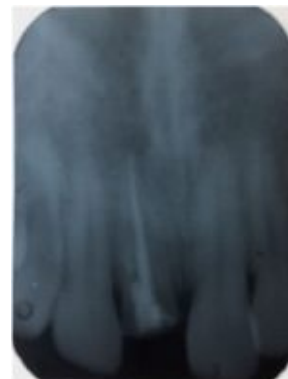
Figure 7 : Post operative IOPA
